**Flood Control Project Maintenance
Levee Inspections**

Fall 2019 Levee Maintenance Deficiency Summary Report

RD0784	Overall LMA Rating	Total LMA Miles							
Reclamation District No. 0784 Plumas Lake	A	33.20							
Rated Item	Maintenance Deficiency				Enforcement		Design & System Obsolescence		
	M Miles	U Miles	M + 4U Miles	Threshold %	M Miles	U Miles	M Miles	U Miles	
<i>Earthen Levee</i>									
Encroachments					2.58	0.49			
<i>Supplemental</i>									
DRAFT DWR UCIP Field Study					0.02				
DRAFT DWR UCIP LMA Responsibility									
<i>LMA Totals:</i>	0.00	0.00	0.00	0.00%	2.60	0.49	0.00	0.00	
Unit No. 01 Yuba River LB	Overall Unit Rating	Total Unit Miles							
RD0784	A	2.21							
Rated Item	Maintenance Deficiency				Enforcement		Design & System Obsolescence		
	M Miles	U Miles	M + 4U Miles	Threshold %	M Miles	U Miles	M Miles	U Miles	
<i>Earthen Levee</i>									
Encroachments						0.49			
<i>Supplemental</i>									
DRAFT DWR UCIP Field Study					0.01				
<i>Unit Totals:</i>	0.00	0.00	0.00	0.00%	0.01	0.49	0.00	0.00

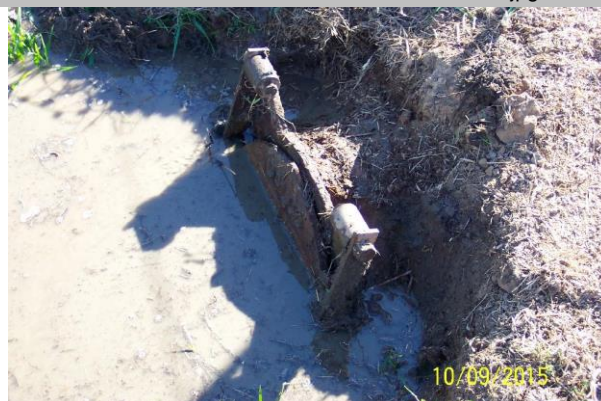
Photo 3 of 3 : UCIP_FA_2019_53550_74710.jpg

Comment Code						
Inspector Comment						
DS_ID:18593 FS_ID:53550 EP_NO: N/A Repair Type: Non-Urgent Crossing Status: Found UCIP Comments: 2/1/2019 - An attempt was made to video inspect this pipe crossing on 8/15/2018 but conditions were too muddy inside the pipe. (P. Meagher)11/14/2016 - Photos added of exposed flap gate on WS and possible inlet location on LS. Condition remains as Non-Urgent because of inlet not being fully operable. Unknown if pipe will operate as designed during high water or if it is full of sediment.11/01/2015 - Waterside Flap Gate Uncovered. Photo sent to DWR Matt Hoffman on 3/3/2014. Fresh photo sent to DWR Pavel Kazi on 9/9/2015. Landside toe has never been able to be located. Requesting DWR inspector to change the status of this issue to "No Action Needed". (P.Meagher - RD784).Pipe buried on LS toe and flap gate is blocked by soil on WS toe. (W. Wylie - UCIP Inspector). FIELD_STRUCT_DESC: 18-inch corrugated metal drainage pipe through the levee, 10 feet below the crown. Flap gate on the waterside (WS) end. [Additional Reference(s): DWR Levee Log, 2005. USACE Sacramento O&M Manual 145, August 1955 (Station 91+50)]. FS Date: 10/9/2015
